UNDERWATER BRIDGE INSPECTION REPORT

STRUCTURE NO. 30501

RUM RIVER

DISTRICT 3 - ISANTI COUNTY

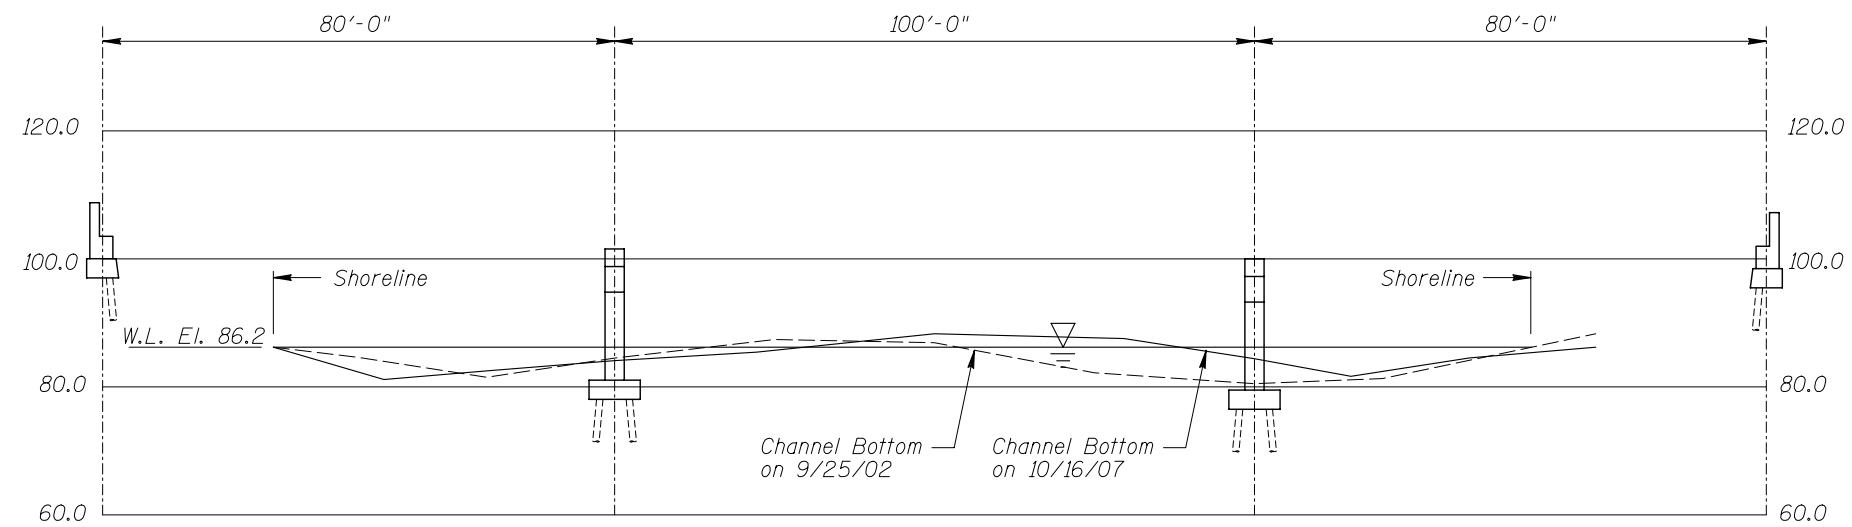
UPSTREAM FASCIA PROFILE

- The channel bottom consisted of silty sand with up to 1 foot of probe rod penetration.
- A scour pocket, 3 feet in radius by 2 feet deep, was observed at the upstream nose of Pier 1 and extended along the pier shaft to the upstream quarter points.
- A band of light scaling was observed around the entire perimeter of both piers and extended from the channel bottom to 2 feet above the waterline with up to 1/4 inch of penetration.
- A scour pocket, 3 feet in radius by 2 feet deep, extended around the entire pier shaft at Pier 2.

REMARKS: Overall, the concrete of the piers was in good condition. A band of light scaling was observed along the entire perimeter of both piers from the channel bottom to 2 feet above the waterline with up to 1/4 inch of penetration. A 2-foot-deep scour depression was observed from the upstream quarter point on the north face of Pier 1 around the upstream nose to the upstream quarter point on the south face. The entire pier shaft at Pier 2 was located in a 2-foot-deep scour depression which extended approximately 3 feet off the pier faces and noses.

Reinspect the submerged substructure units at the normal maximum recommended (NBIS) interval of five (5) years.
